Failure Analysis and Optimization of Epoxy Insulating Sleeves in Preloaded Flange Joints

Pruthviraj Ambadas Hatkar¹

¹B. E. Mechanical Engineering

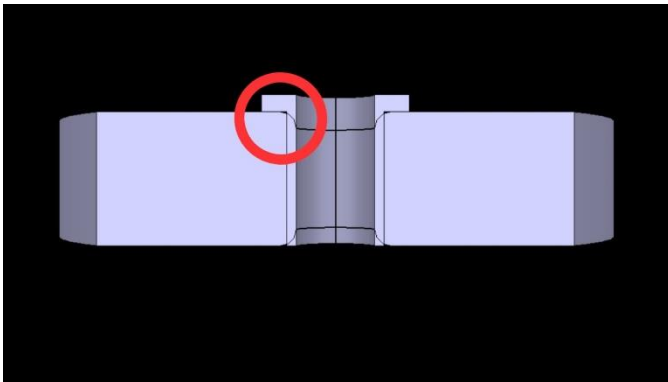
Fig -2: Assembly Before Modification 3

- **Change:** Ensuring proper matching between the flange hole radius and the sleeve neck radius
- **Issue Addressed:** Excessive clearance and improper seating of the sleeve within the flange
- **Outcome:**
 - Improved fit and alignment
 - Reduction in unintended movement and stress concentration
 - No cracking observed
