# Development of a Drainage Control System for Water Leakage from Metro Bridge Expansion Joints

*Abstract— The problem of leakage through the expansion joints of bridges carrying elevated metro lines is of great importance in urban engineering, as water leakage from such joints falls directly on the roads and footpaths, posing dangers of injury to pedestrians and vehicles, and deterioration of bridge structures such as the caps of piers. This research suggests a unique drainage scheme where there is provision of a 150 mm height wall that will collect all the water leaking out of the joints into a 50 mm drainpipe and transfer them to the ground level. Such a system will help in avoiding unnecessary water flow, prevent the structure from deterioration due to continued seepage and ensure safety of both pedestrians and vehicles. Additionally, this drainage arrangement will help in reducing maintenance needs of the system and increase its longevity. This paper presents an approach to the design and implementation of the suggested scheme.*

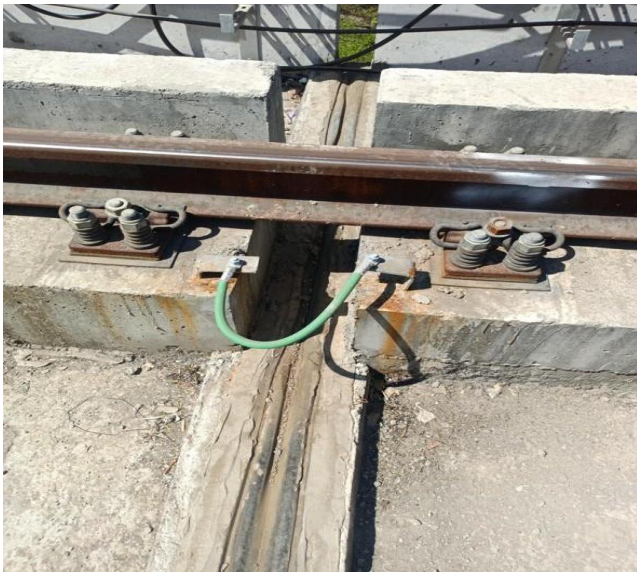
Figure 1: Expansion Joint in Metro

Expansion joints form some of the key structural elements that are installed on bridges in order to allow for movement resulting from various factors such as changes in temperatures, vibrations from traffic loading, vibration from traffic vibration, shrinkage, and seismology among others. In elevated metro bridges, expansion joints play a significant role in ensuring that movements occur in a controlled manner in order to prevent the formation of stress and cracks on structural components.

However, despite being critical to the stability and durability of structures, expansion joints are subject to difficult environmental conditions such as water, dust, and traffic vibration. Damaged joints form the main sources of water leakage in elevated metro bridges, especially since rainwater that gets into joints drips directly onto roads, pedestrian walkways, as well as bridge substructure elements. This can pose safety hazards as well as cause deterioration of the structure, including corrosion of reinforced concrete and steel.

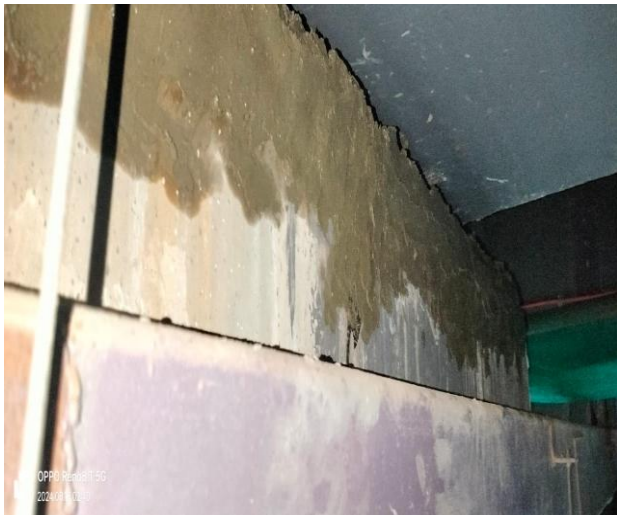
Figure 3: Deterioration due to water seepage

In addition to posing dangers to public transport users, water leakage also creates problems regarding the structural elements of the bridge. Leakage of water causes moisture accumulation on structural elements and results in corrosion of concrete and reinforcement, deterioration of concrete, stains on the concrete surface, and a shortened lifespan of the structural elements. In most cases, leakage of water around structural elements of the bridges necessitates frequent maintenance work. Thus, efficient water management and drainage from expansion joints are vital for better performance of bridges.

Water logging caused by leakage at the expansion joint in an elevated metro bridge is a critical concern. During the rainy season, water collects around expansion joints that have been damaged or sealed inadequately and starts to leak out of them. Leakage water drips to the ground, causing water to log on the roads, pathways, and even public places located under the bridges. Continuous leaking of water on road surfaces results in slippery road surfaces and traffic hazards such as lack of visibility, which increases the probability of accidents.
